## Preliminary Survey of Water Hyacinth in Lake Tana, Ethiopia

Investigation of water hyacinth was conducted from October 27, 2011 to November 3, 2011 by interdisciplinary expedition groups. A total of 24 sites were delineated using geographical positioning system (GPS) during investigation of water hyacinth incidence along the whole periphery of Lake Tana. Water hyacinth was started from Mitreha Abawarka kebele of Gondar zuria woreda specifically around at Netseba village with an estimated of 3 hectare area coverage. Highest infestation of the weed was observed at Megech River mouth with estimated area coverage of c. 80-100 hectare. Its infestation extends up to Dirma River mouth. Especial adaptation of water hyacinth on land based conditions at which soil moisture relatively high was observed around Tana woina kebele of Gondar zuria woreda adjacent lake shore side. The incidence and depth of water hyacinth infestation in Lake Tana is still at its infant stage, because except the North and to some extent North-east direction, the other parts of Lake Tana were devoid of the water hyacinth. Generally water hyacinth remains a major problem in Lake Tana where effective control progra

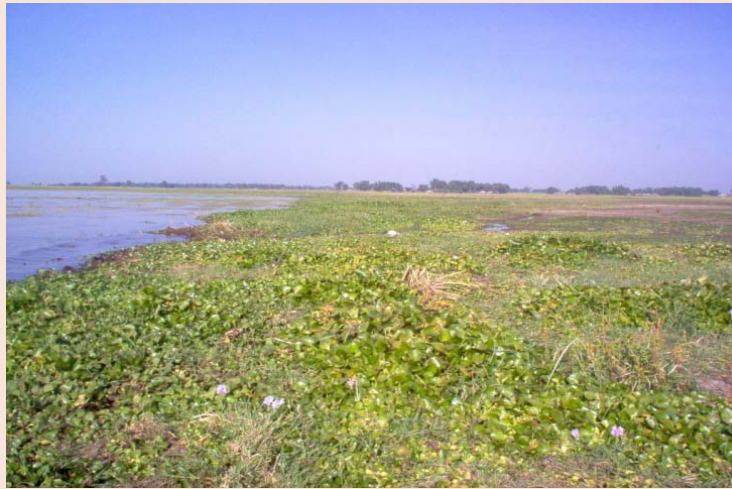
Figure 1: Water hyacinth invades both grazing and farm lands around Tana woina kebele of Gondar zuria woreda.

A total of 24 sites were delineated using geographical positioning system (GPS) during investigation of water hyacinth incidence along the whole periphery of Lake Tana. As a result the weed was started from Mitreha Abawarka kebele of Gondar zuria woreda specifically around at Netseba village with an estimated of 3 hectare area coverage (Table 1). The most devastating area coverage by the weed was observed at Megech River mouth extended both east and north direction with estimated area coverage of 80-100 hectare and widely distribution of daughter plants observed that moved forward by the assistance of the wave. Especial adaptation of water hyacinth on land based conditions at which soil moisture relatively high was observed around Tana woina kebele of Gondar zuria woreda (Figure 1).

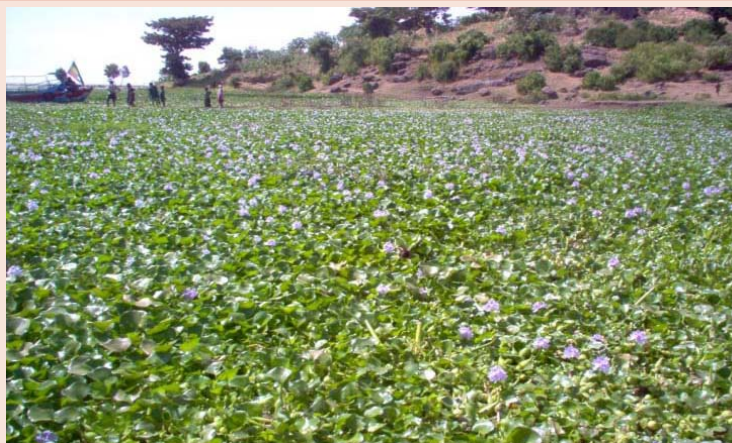
**Figure 3:** Water hyacinth blooming around Netseba village of Mitireha Abaworka kebele during the survey.

North-west, West, South-west, South, South-East and Eastern parts of the lake was totally devoid of water hyacinth (Figure 2). Therefore, the most possible explanations would be birds because the infested area is known by cross boundary bird species, fishing equipments, wastewater treatments, and ornamental purposes in general it might be again introduced by human activities. Regarding to its introduction time, about 50 percent of the respondents replied that the weed has been introduced in the area with in two years time and the other 50 percent respond, as it has only been observed since July, 2011. During the survey, water hyacinth was at its 60 percent blooming stage that is ready to set its copious seeds (Figure 3).
