Dereje Tewabe*

Research Article

Impacts of Furrow Irrigation on Shesher and Welala Natural Reservoirs of Lake Tana Sub Basin, Ethiopia

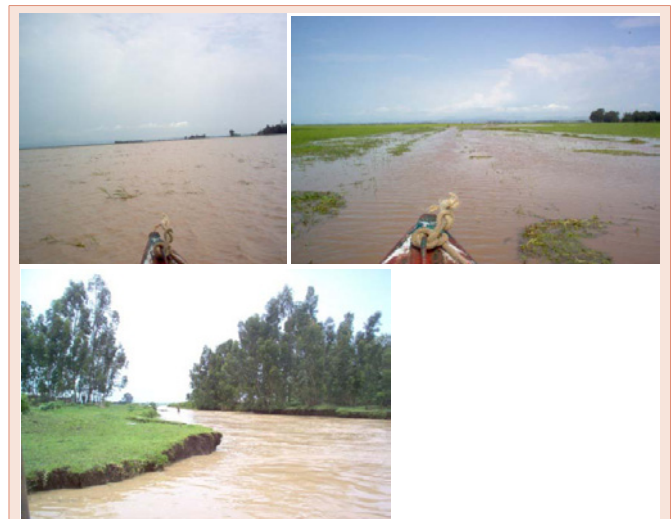
Figure 2: Shesher reservoir during rainy season, and joining Lake Tana from left to right (Photo: Dereje Tewabe, 2012).

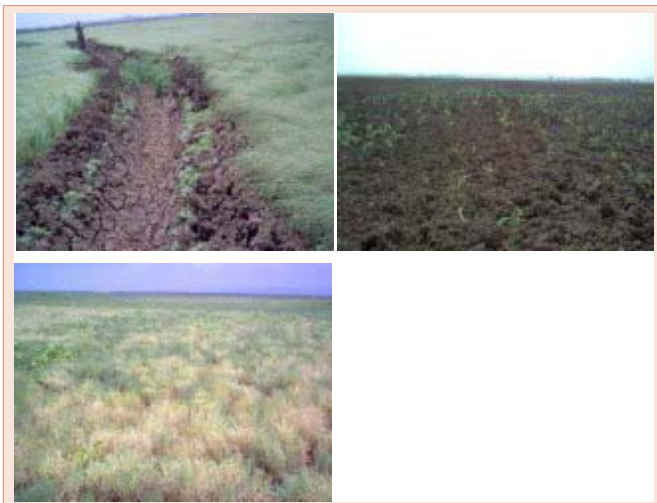
Figure 4: Major crops cultivated by draining water through furrow irrigation system from Shesher reservoir of Lake Tana wetland.

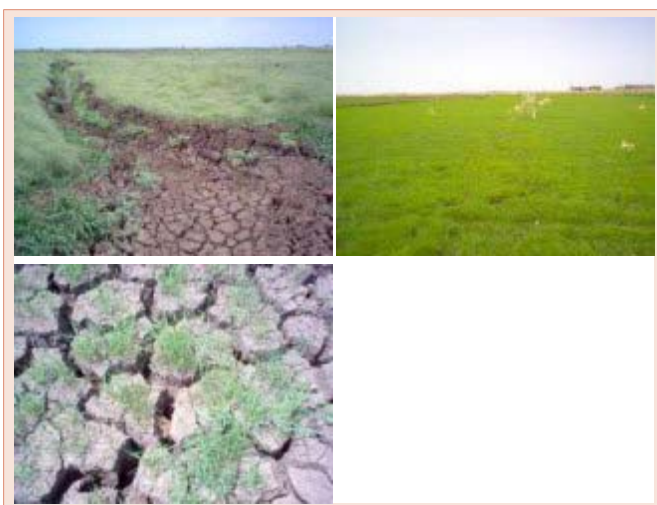
Un studied water use that is extensive use of irrigation to all directions of the reservoir causes shortage or even loss of whole available water which leads to wilt and dried of crop prior its ripening periods, there has been a lot of clues such as cracking of soil at early stage of *Eragrostis teff* and its color also indicates its future negative fate that might end up with non ripe seeds (Figure 5).

Figure 5: Lack of irrigable water that shows cracked soil and poor plant color of *Eragrostis teff* that might lead to wilt and death of a plant prior to ripe.

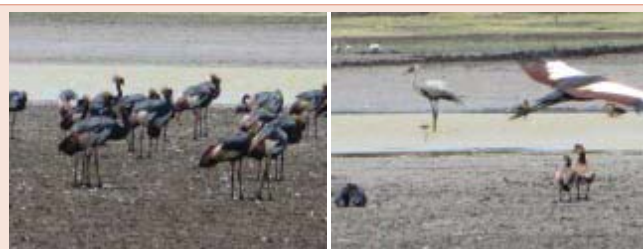
Figure 10: Ecotourism and fisheries are assumed to be an appropriate intervention in Welala wetlands of lake Tana.

Especially fishes and birds are seriously affected during the pick dry seasons of the area and it is not uncommon to see remnant dead fishes eaten by birds (Figure 9). If Welala wetland could be protected from several imposed activities from the inhabitants it might be properly exploited by designing appropriate interventions for instance it can serve for fisheries and ecotourism activities (Figure 10).

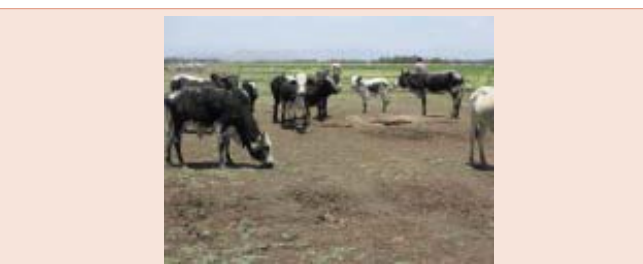
from underground water and feeds from supplements probably of crop residues (Figure 11). The area is known for breeds of Fogera with their high performance traits.

Figure 11: A paradox, cattle production system awaiting for watering from the well and supplemented feed stuffs from crop residues.
