Research Article

Impacts of Furrow Irrigation on Shesher and Welala Natural Reservoirs of Lake Tana Sub Basin, Ethiopia

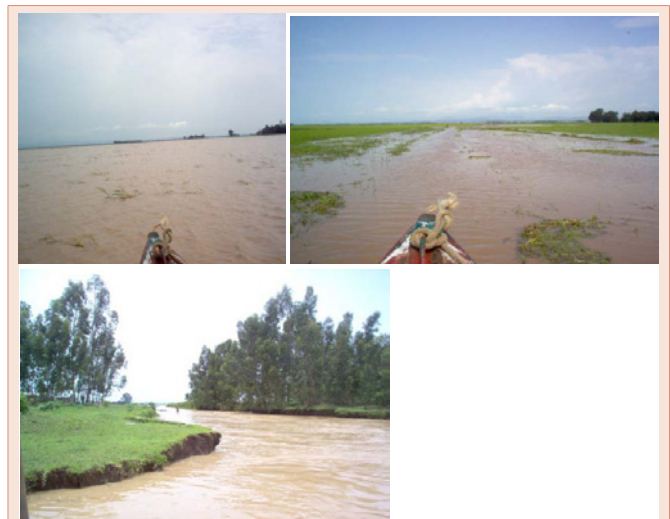
Figure 2: Shesher reservoir during rainy season, and joining Lake Tana from left to right (Photo: Dereje Tewabe, 2012).

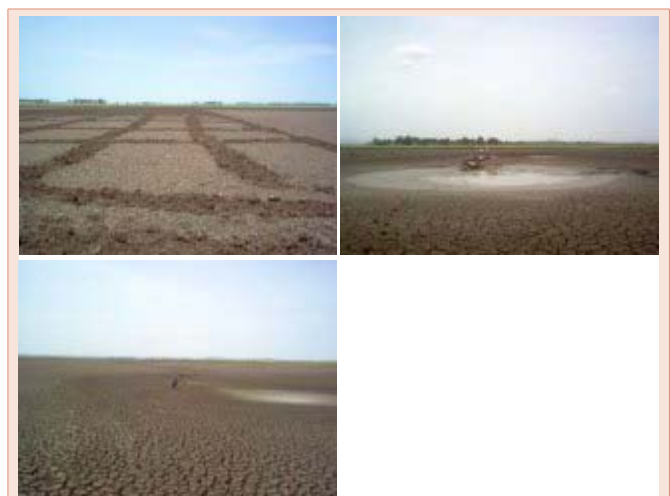
During pick dry season of March, 2012 the survey showed unexpected, amazing and sudden death of a home for many biodiversity and life full of Shesher natural resource dried up totally and birds fetch their food from remnants small shrieked wet mud spot (Figure 3). This happened due to several and unlimited human encroachments for different activities mainly for crop cultivation, with out any rules and regulations. Major crops cultivated by drained Sheshers water using gravitational force were *Eragrostis teff*, Cheak pea, Lentils and Safflower (Figure 4). It seems the community lacks knowledge and awareness about Shesher reservoir wetland of sustainable use other than exploiting beyond its maximum limit.

Figure 3: Total dried up of Shesher reservoir with shrieked mud aggregated by birds at the center.

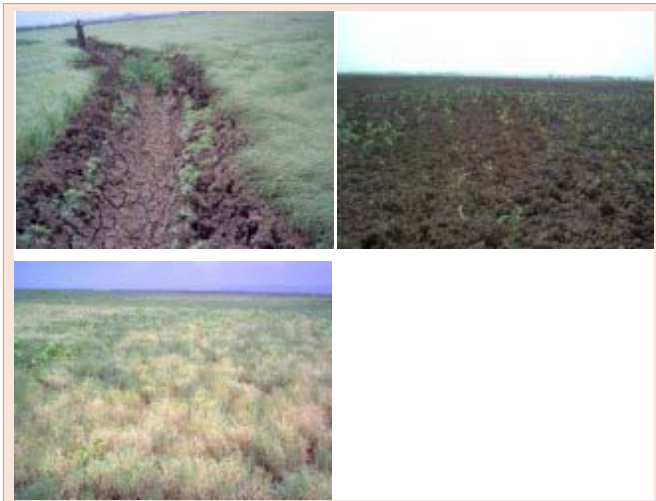
Figure 4: Major crops cultivated by draining water through furrow irrigation system from Shesher reservoir of Lake Tana wetland.

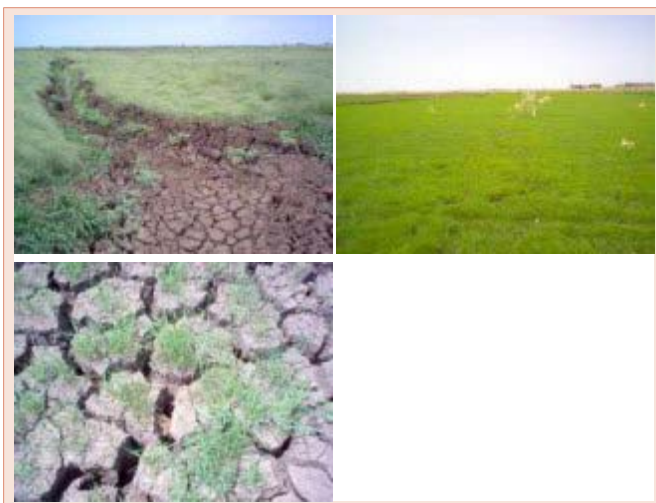
Un studied water use that is extensive use of irrigation to all directions of the reservoir causes shortage or even loss of whole available water which leads to wilt and dried of crop prior its ripening periods, there has been a lot of clues such as cracking of soil at early stage of *Eragrostis teff* and its color also indicates its future negative fate that might end up with non ripe seeds (Figure 5).

Figure 5: Lack of irrigable water that shows cracked soil and poor plant color of *Eragrostis teff* that might lead to wilt and death of a plant prior to ripe.

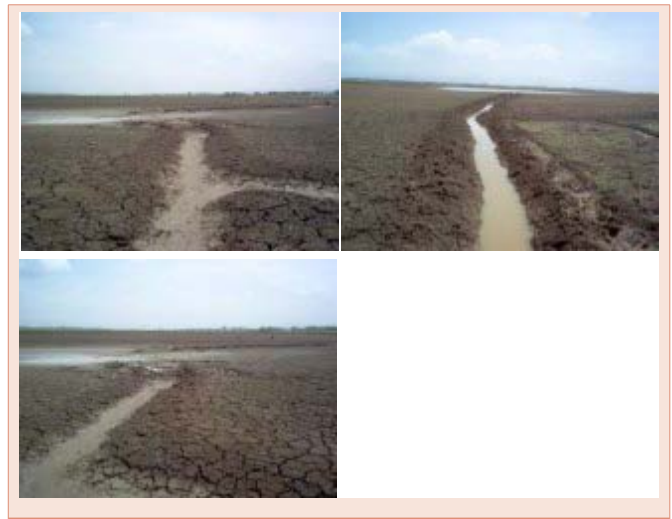
Such type of irrigation system in Shesher reservoir could not be recommended practice because it is not well studied and high pressure was imposed from four kebele inhabitants of its surrounding without calculating its carrying capacity, it drained until the water lost from the area by making furrows even followed its small shrinkage (Figure

Figure 6: Uncontrolled drainage of Shesher reservoir for irrigation purpose until it totally dried up from the area.

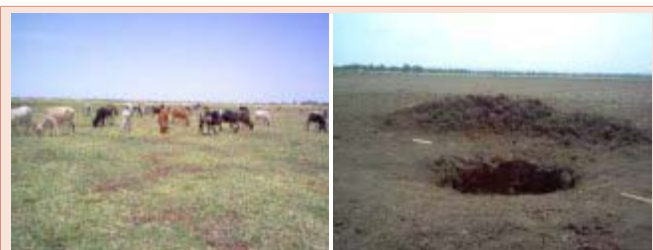
6). Water could not be found even for drinking of their animals and for themselves, as a result they started digging of the ground to fetch water for themselves and their animals (Figure 7).

Figure 7: Digging ground water (Well) at the center of Shesher reservoir for their animals after complete dried up of the reservoir.

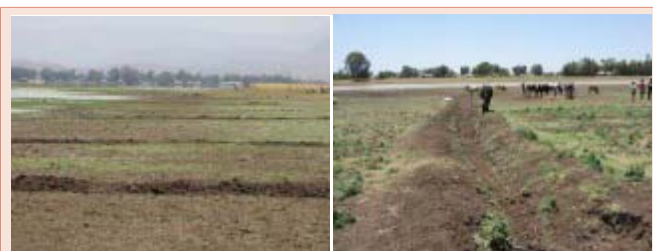
Figure 8: Furrows of Welala reservoir with 50 m intervals at both sides of farm lands to irrigate their crops.

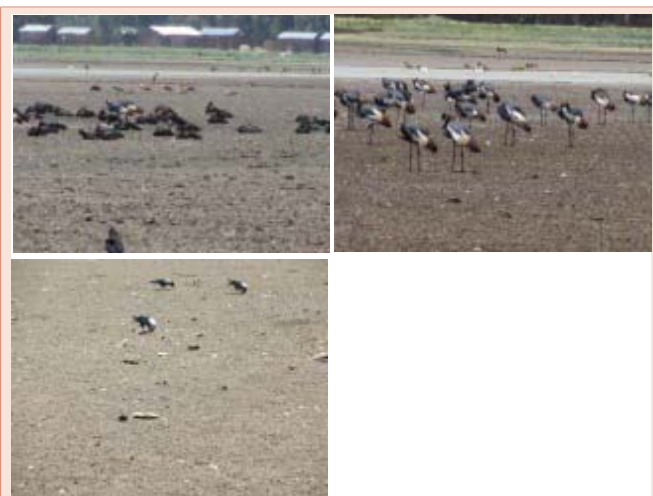
Especially fishes and birds are seriously affected during the pick dry seasons of the area and it is not uncommon to see remnant dead fishes eaten by birds (Figure 9). If Welala wetland could be protected from several imposed activities from the inhabitants it might be properly exploited by designing appropriate interventions for instance it can serve for fisheries and ecotourism activities (Figure 10).

Figure 9: Highly populated birds and remnant dead fishes eaten by birds in the highly shrunk and almost dried Welala wetlands.
